From: Tisa, Kimberly
Sent: Thursday, November 3, 2016 2:45 PM
To: Mike Zarba
Cc: Gary Trombly; Tisa, Kimberly
Subject: FW: FW:
Attachments: IMG_1050.JPG; IMG_1049.JPG; IMG_1047.JPG; IMG_1045.JPG; IMG_1040.JPG

Kim – I have been asked by my client (Garcia & Milas) to forward these photos taken at the site this morning. Standard Demolition Services asks the following:

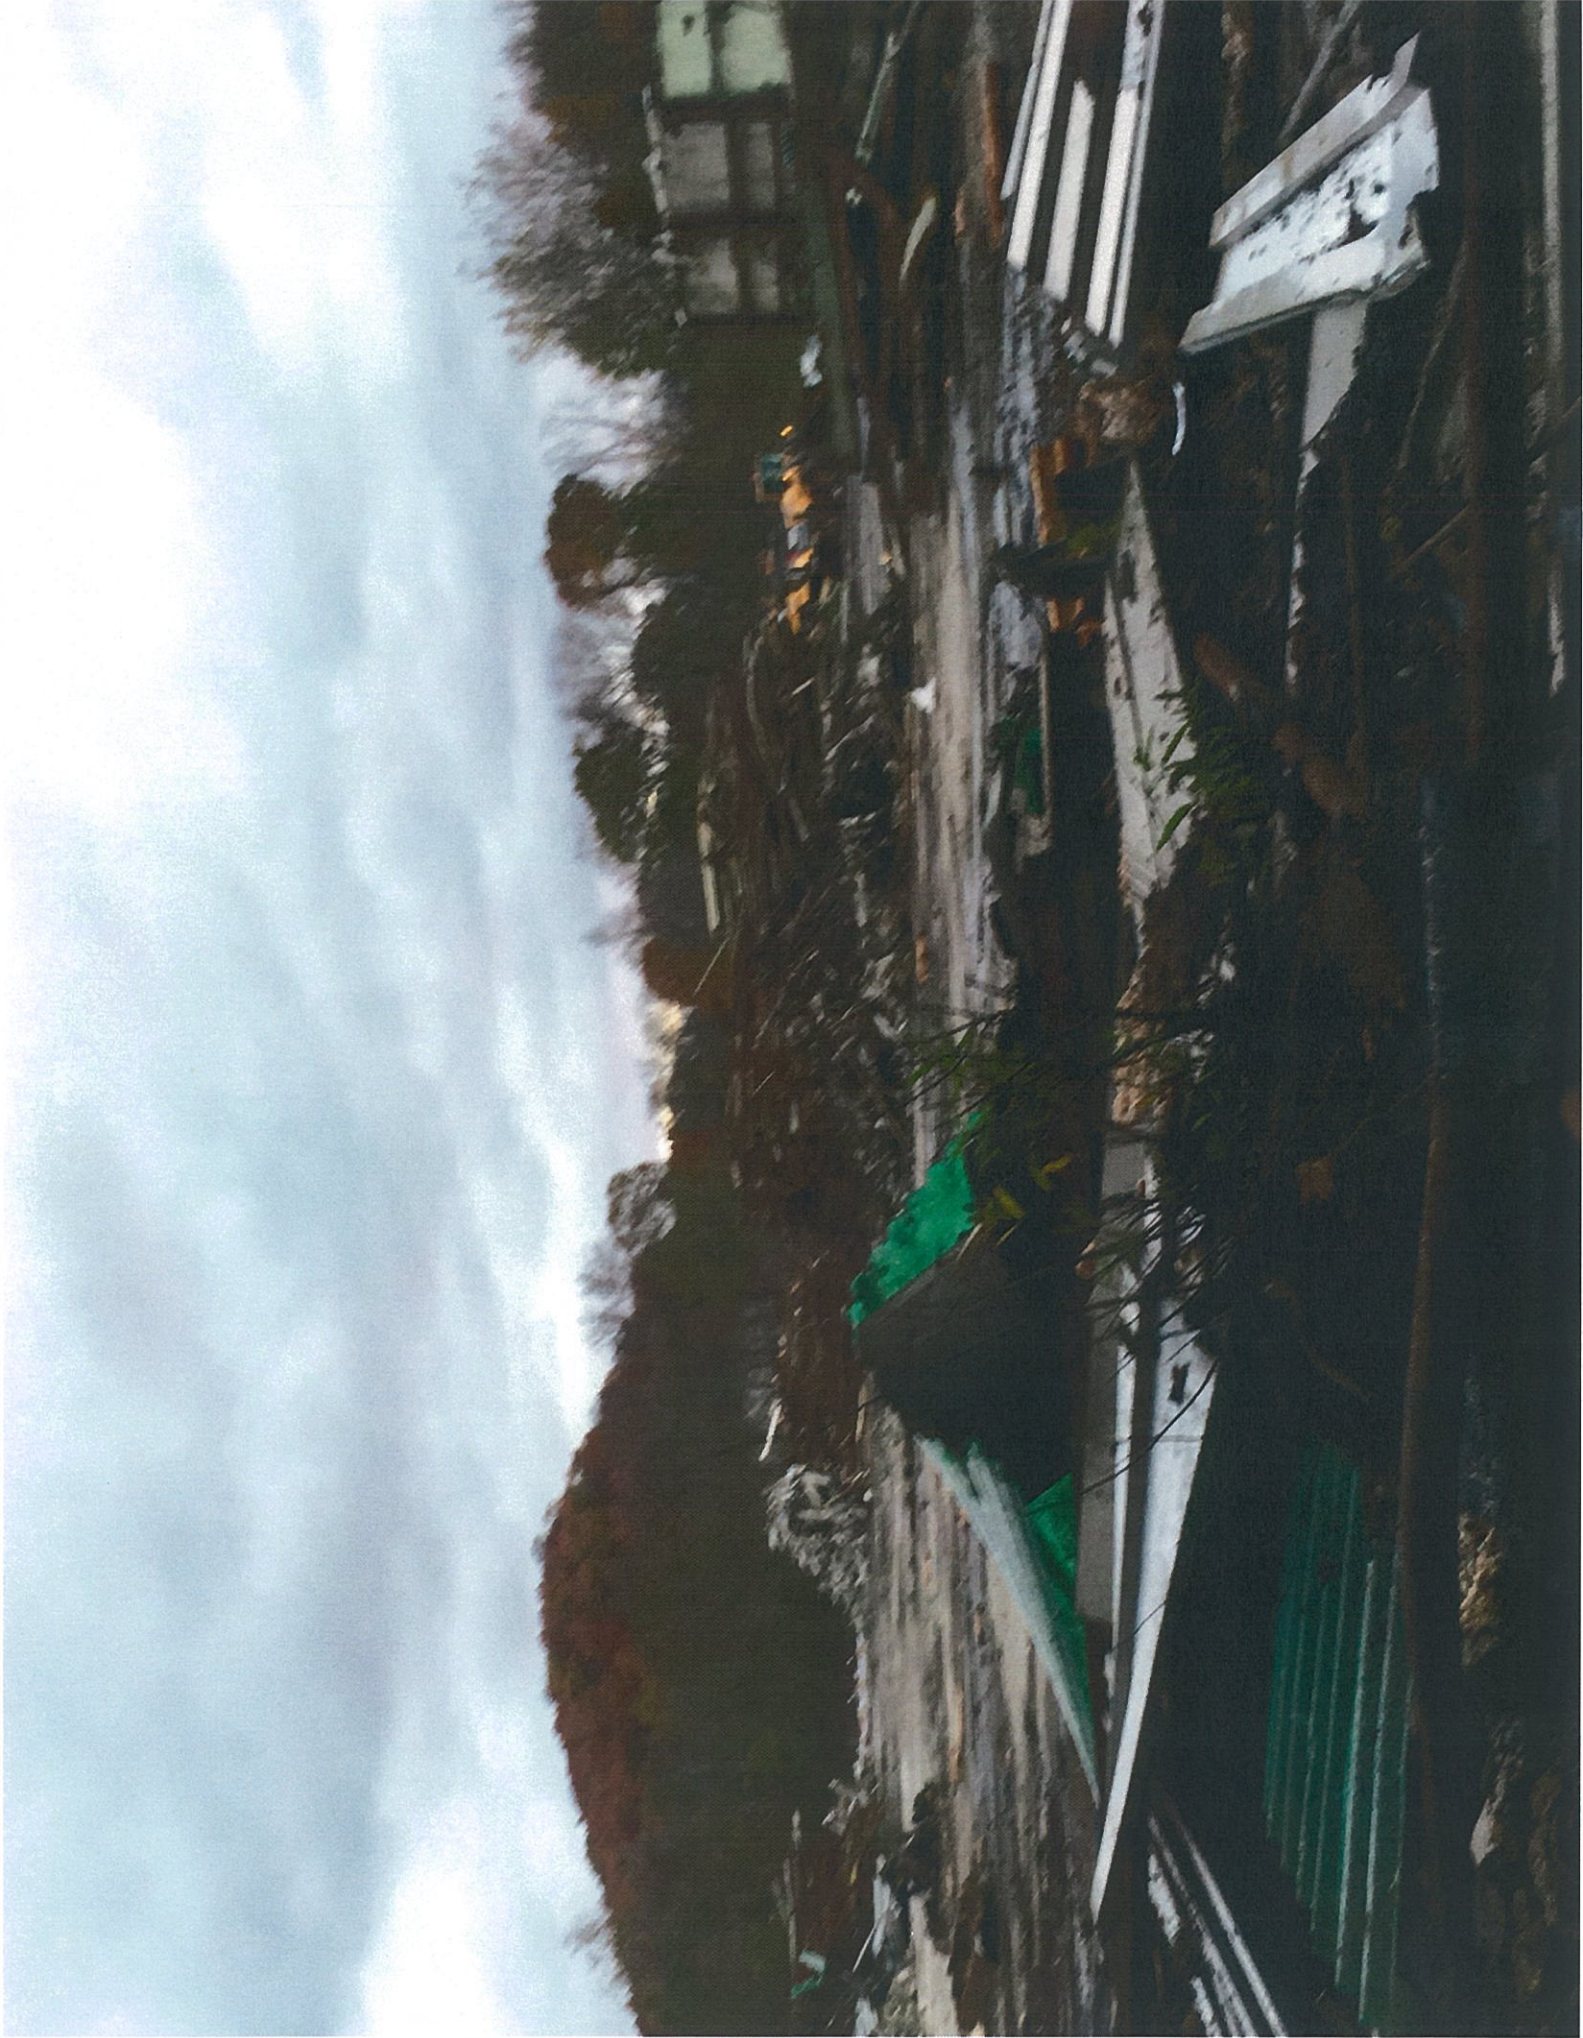
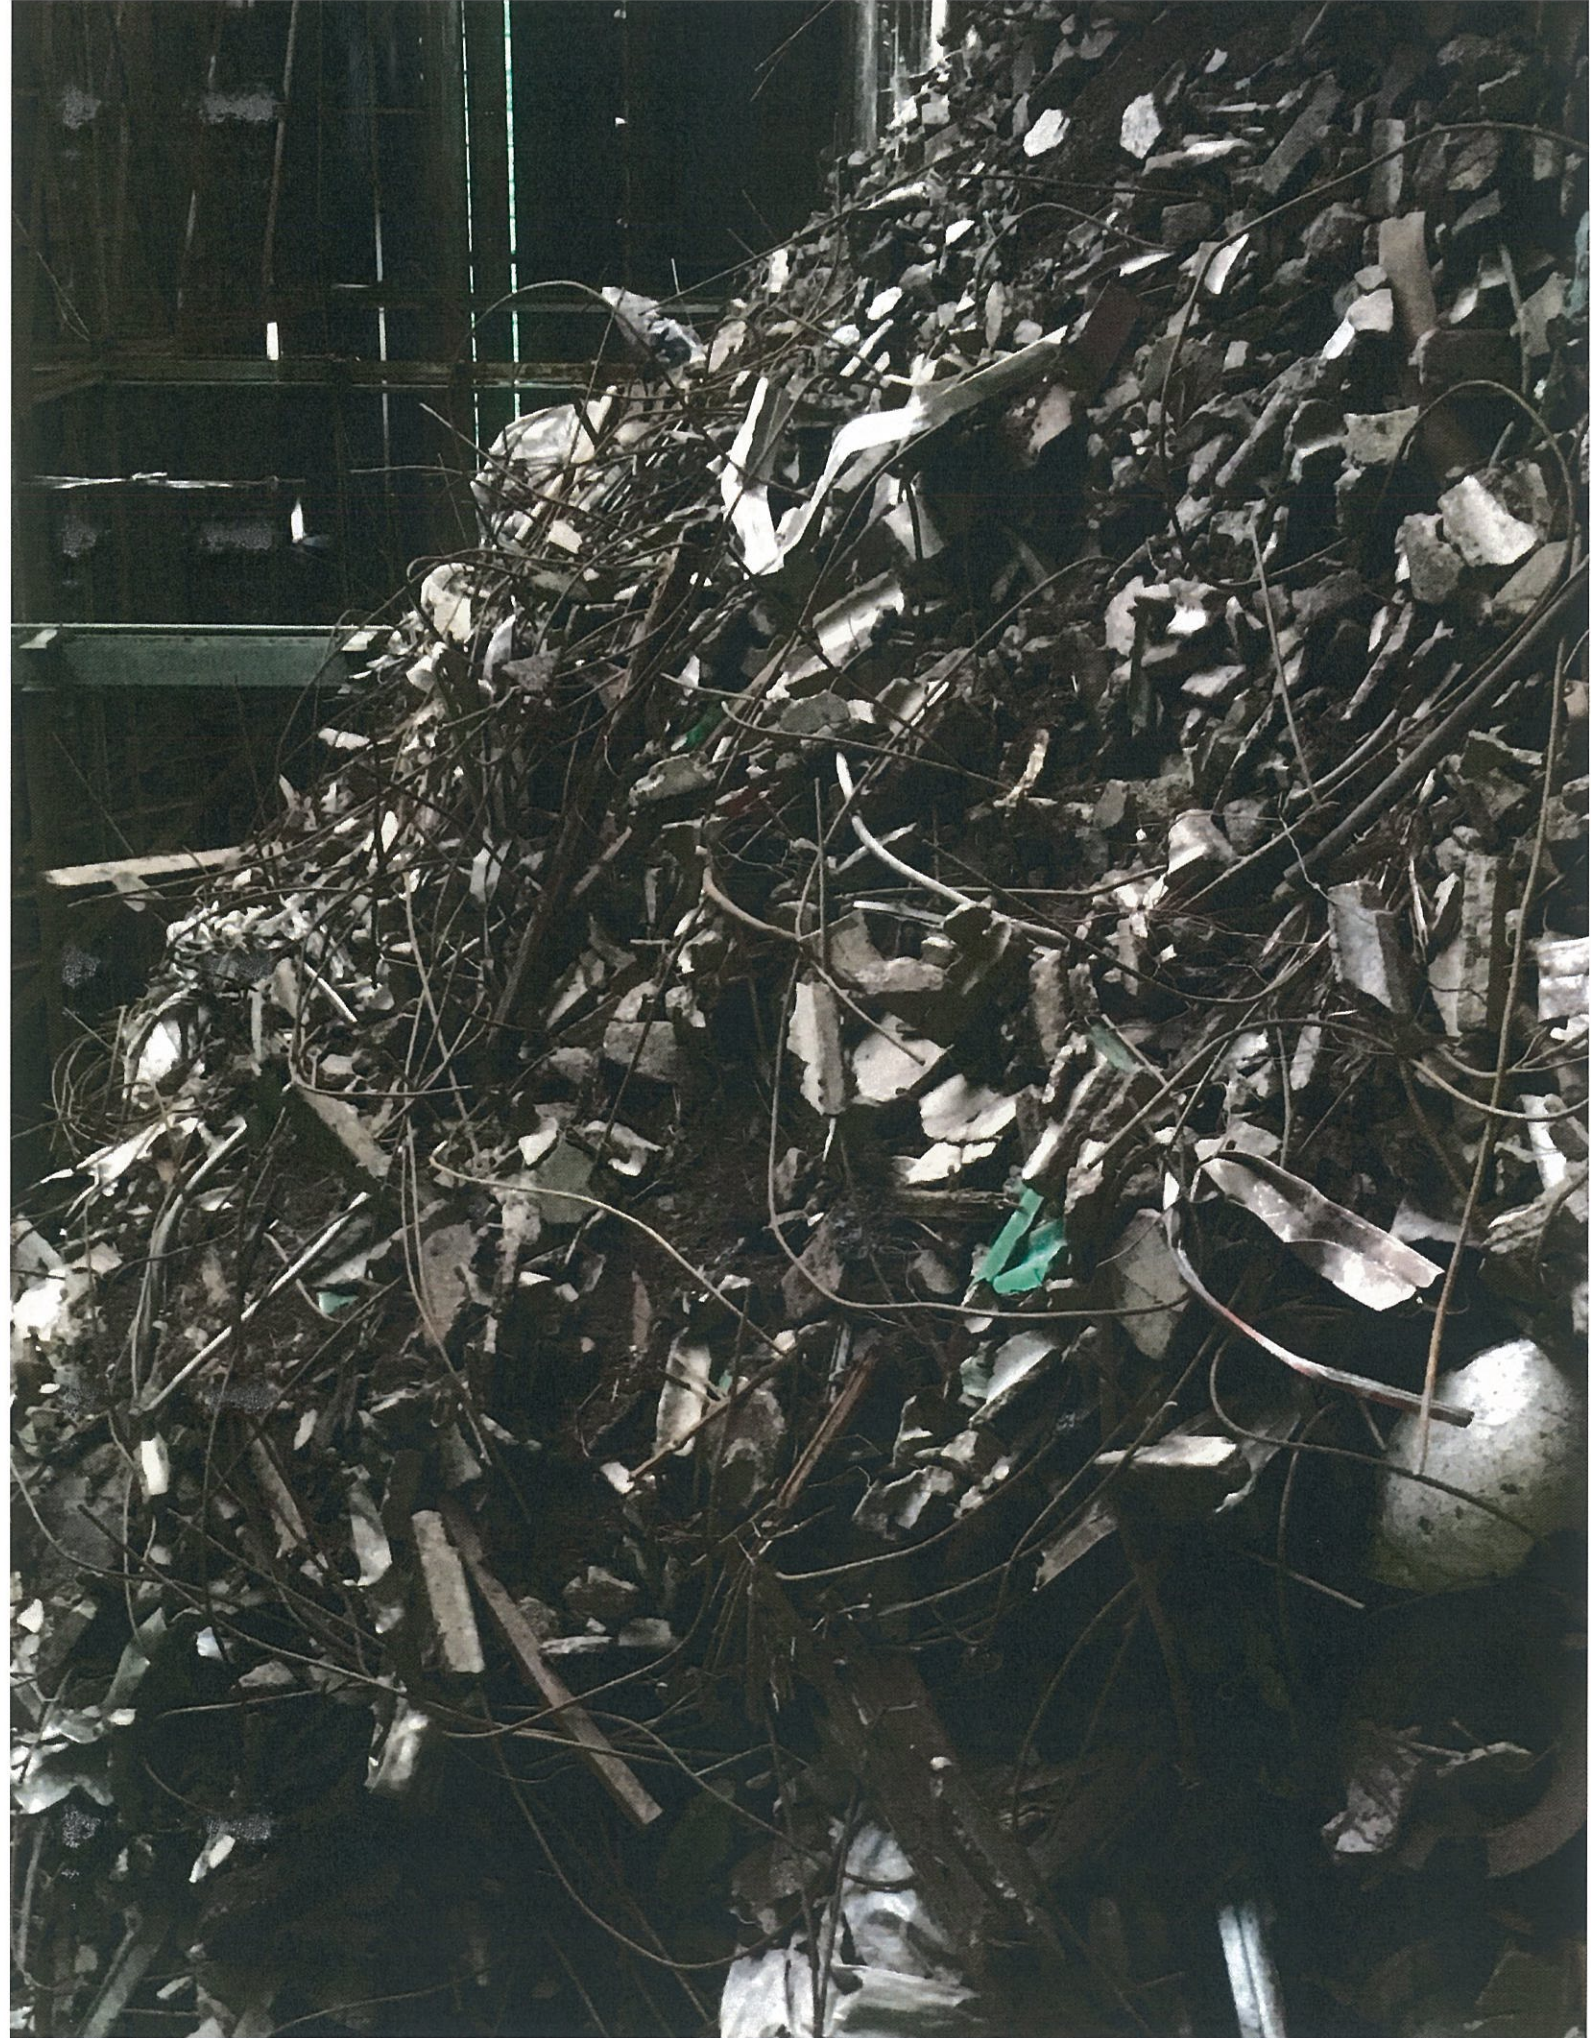
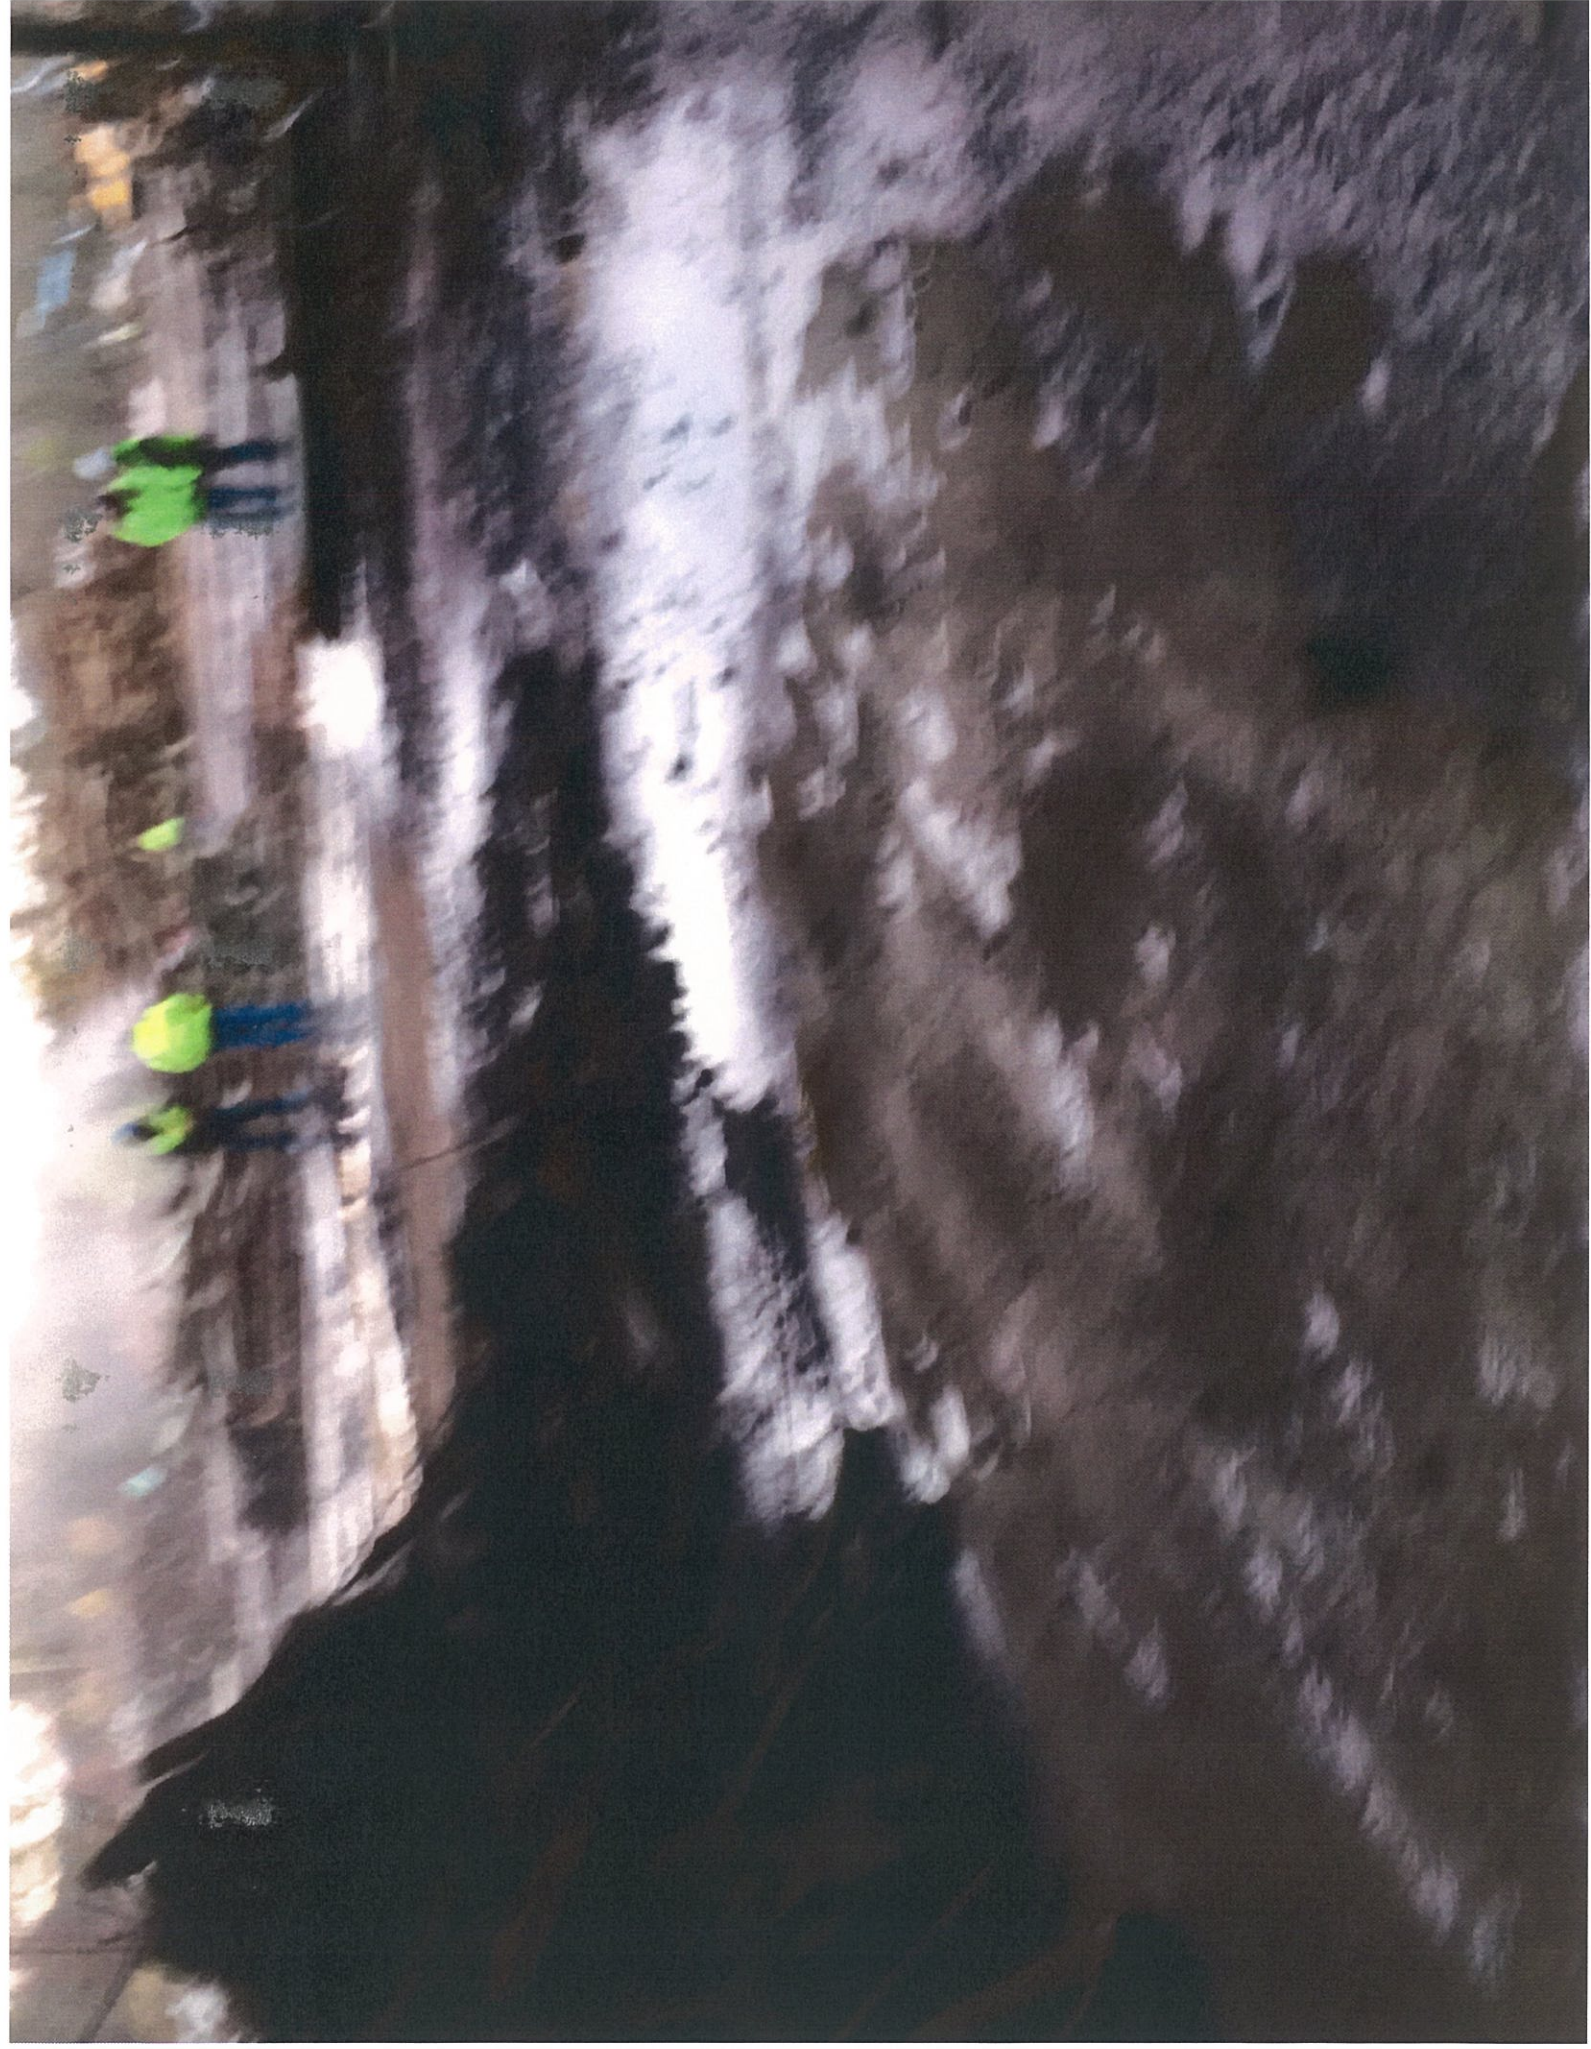
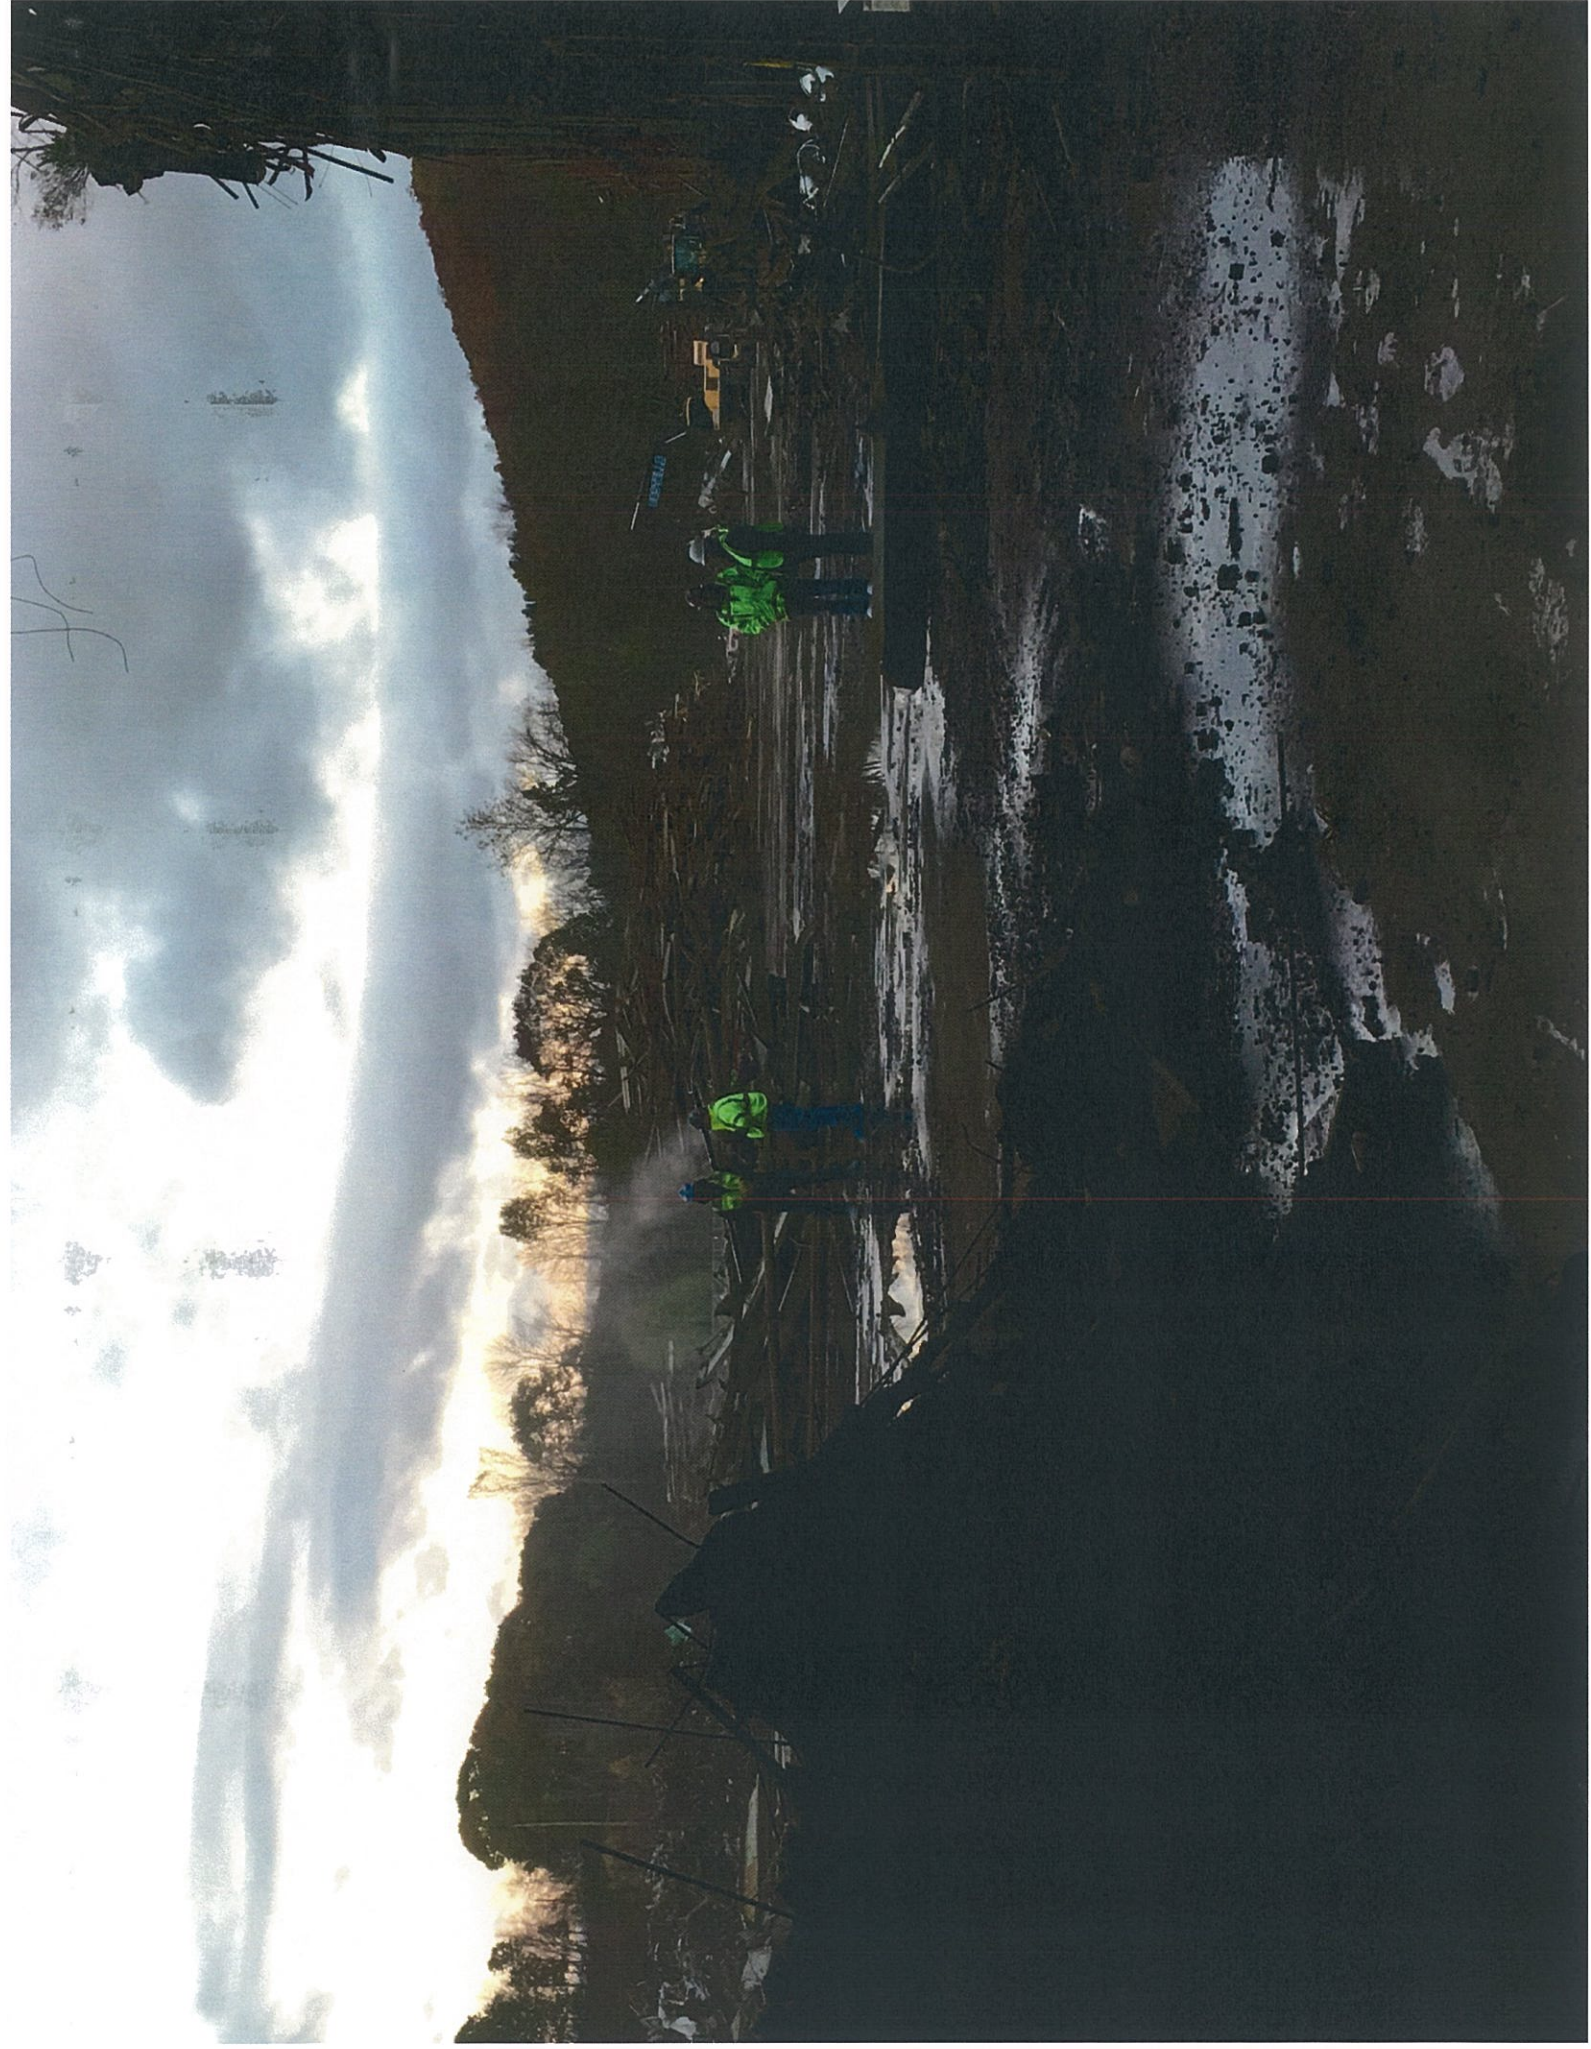
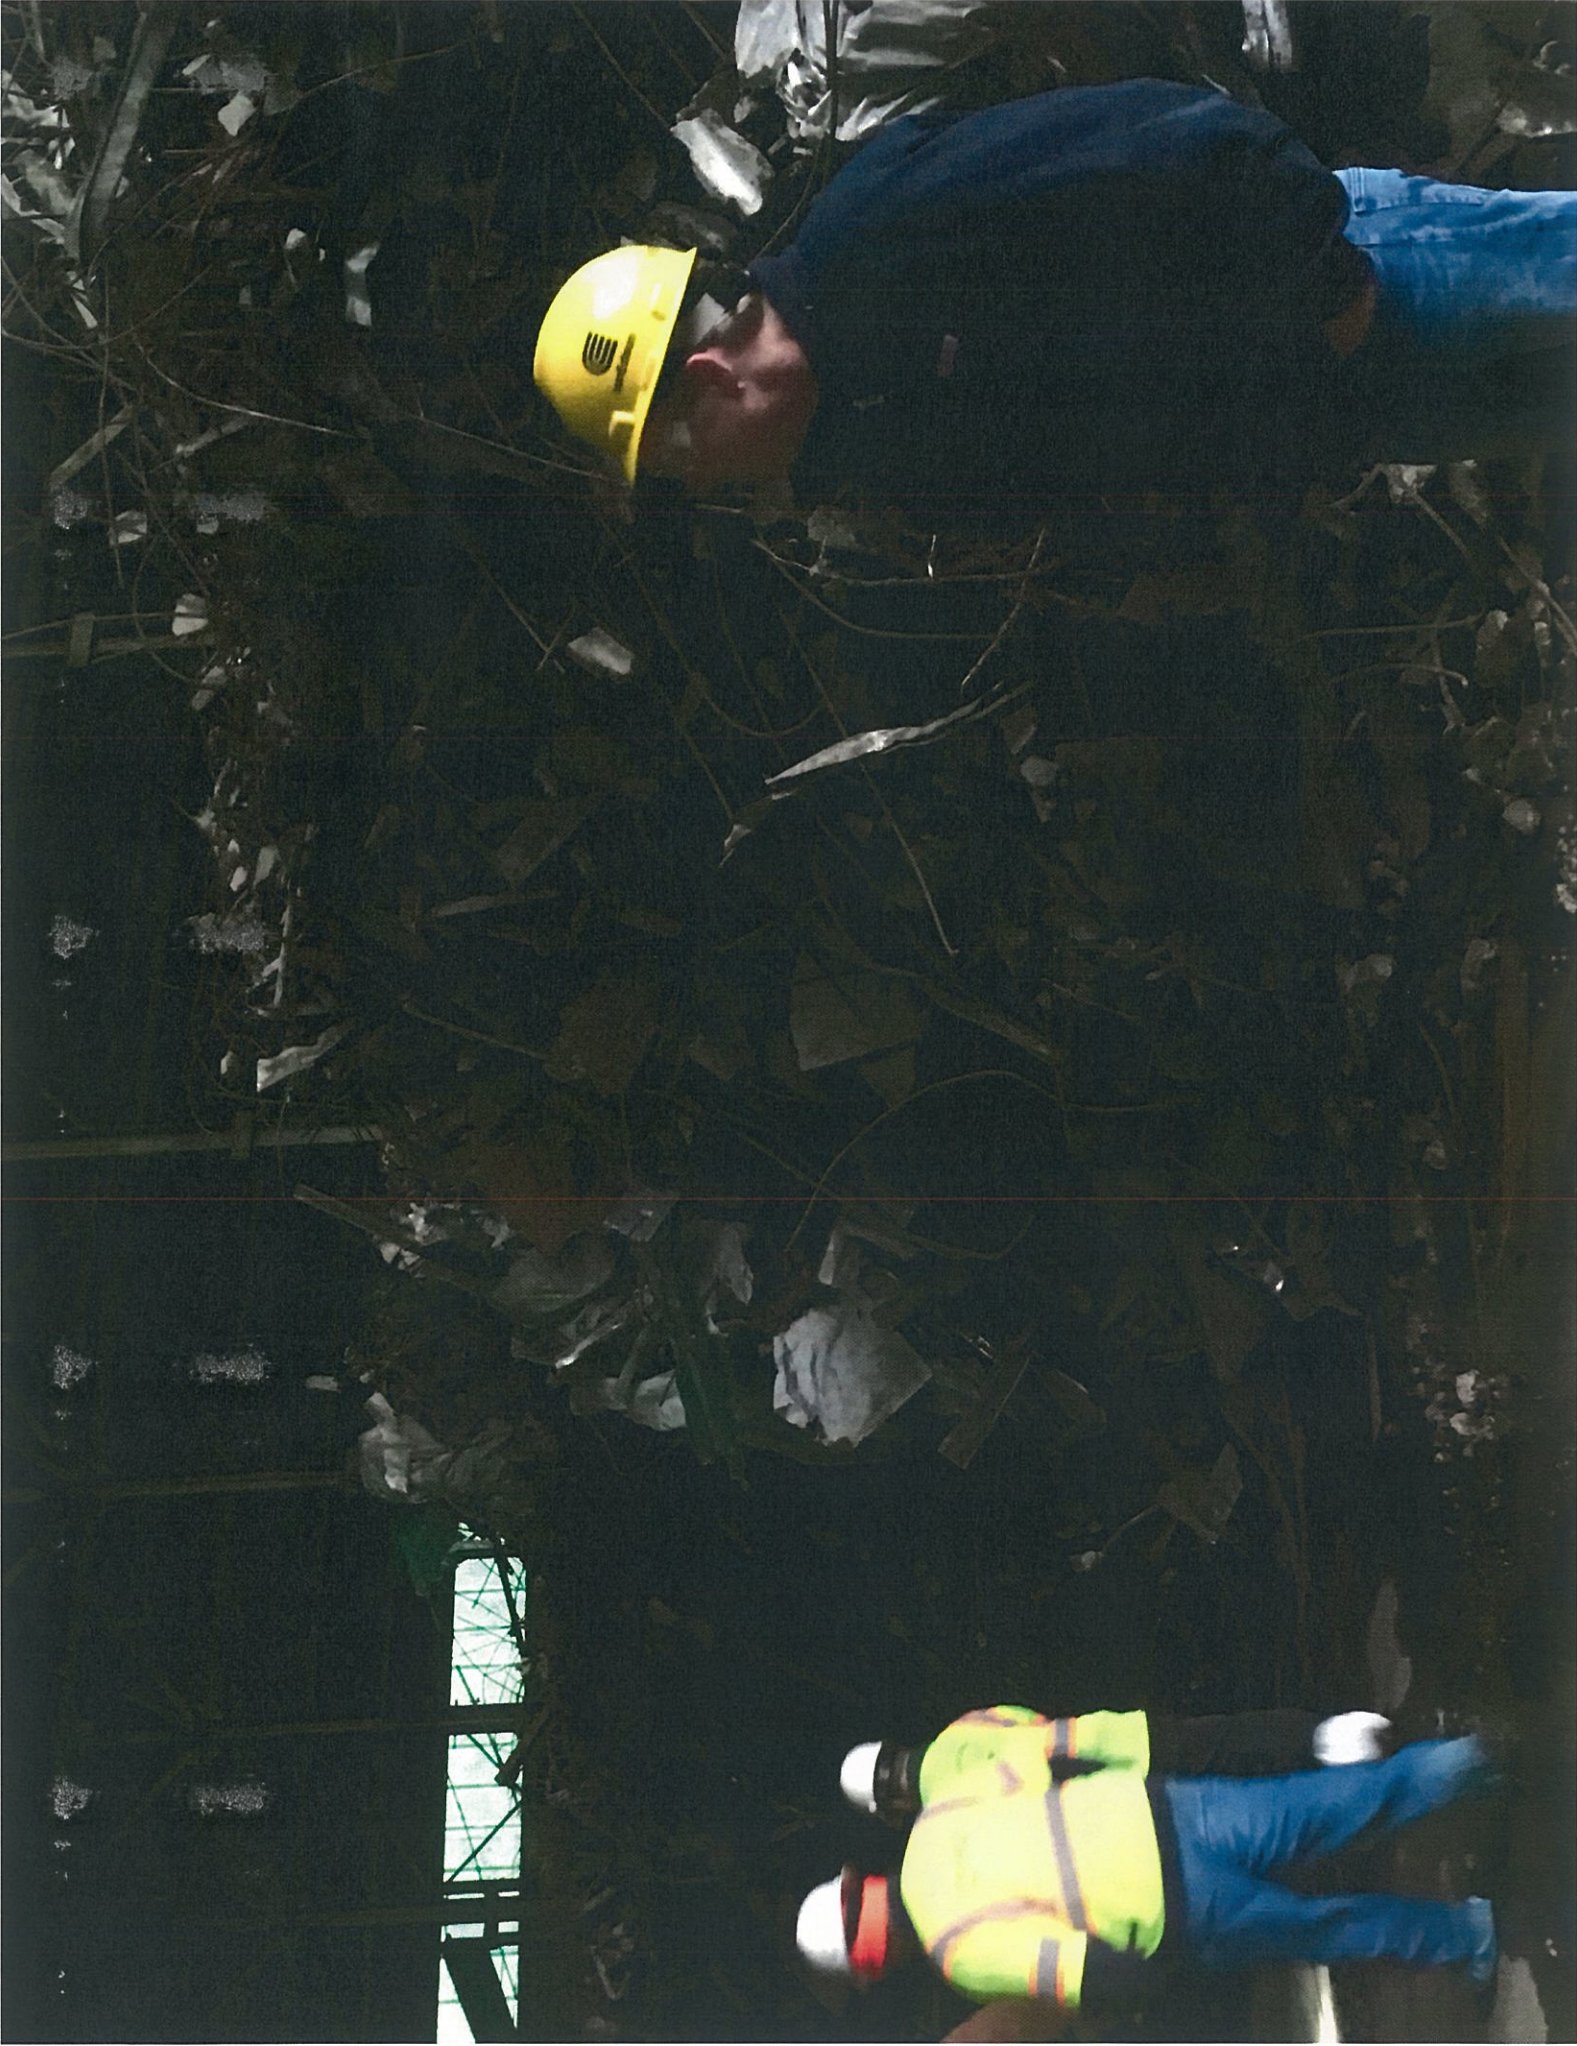
the roofing materials and other c&d items were stockpiled on the slab without a poly separation between the floor (which is considered remediation waste) and the roofing/ c&d materials. What happens to handling and disposal in that situation? Is the roofing / c&d now considered PCB contaminated because it is on the contaminated slab etc.? What is the EPA's position on that?
